A Flight Test Evaluation of the Grob G-102 Club IIIB

by RICHARD H. JOHNSON

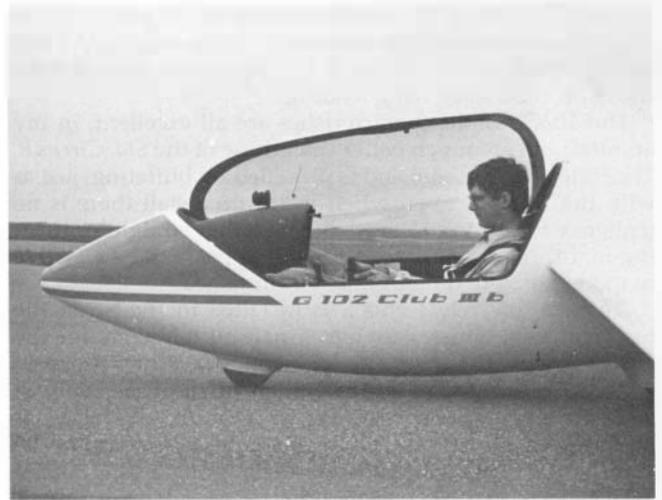
At six feet two inches, test pilot Bruce Beddow fits nicely into the Club IIIb, whose faired nose wheel allows for heavy braking on landing.

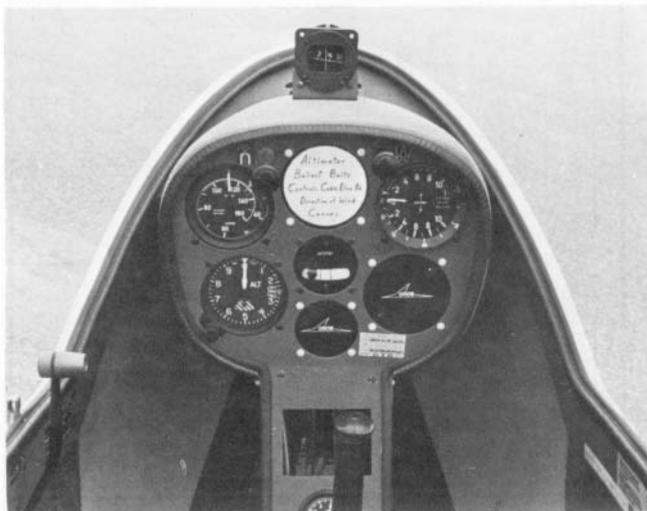
Simple, uncluttered Club IIIb panel mounts airbrake/wheelbrake handle on left just above elevator trim lever. The tow release is positioned low on the left edge of the center pedestal below the instrument panel.
